# Life test result of Ricor K529N 1Watt linear Cryocooler

Ilan Nachman, Alexander Veprik and Nachman Pundak  
Ricor Cryogenic and Vacuum Systems, En Harod Ihud, 18960, Israel

## ABSTRACT

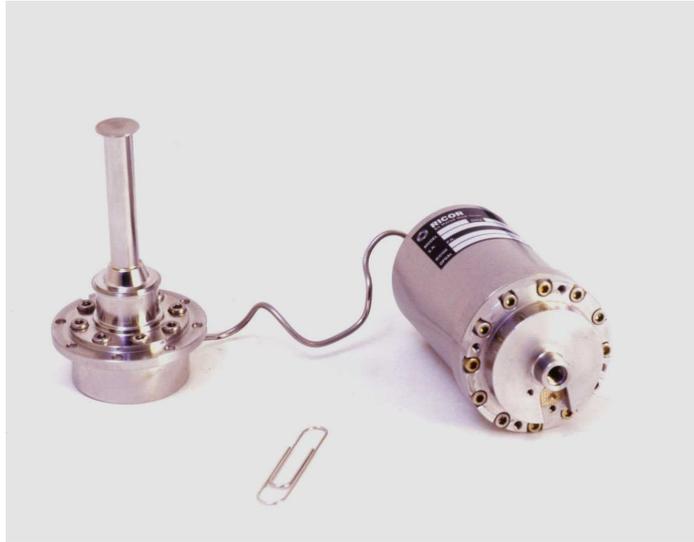
Figure 1: Ricor Type K529N Cryocooler.

In Figure 1, the Ricor Type K529N Cryocooler consists of the single-piston linear compressor, pneumatically driven expander and transfer line.

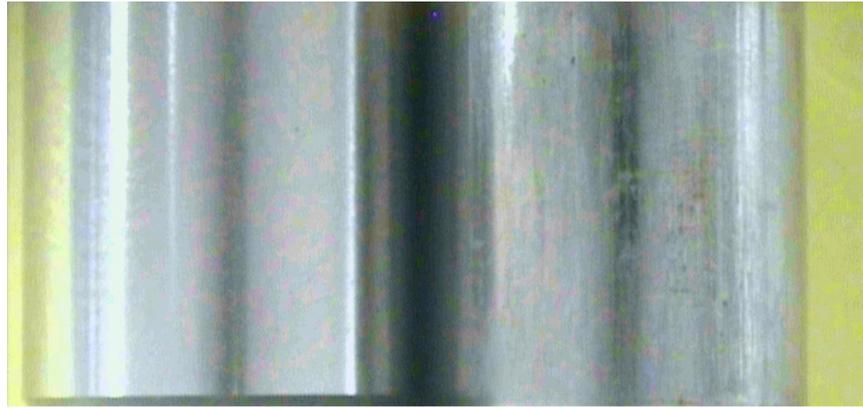
Figure 4: Compressor piston: "before and after".

The moving piston sub-assembly accurate reciprocation and compression ratio developed by the compressor depends entirely on the technical condition of these two rubbing parts. Examination has shown that after 27,500 working hours the above parts were in excellent condition: the sliding was free, the piston and cylinder geometry remained unchanged.

The flow rate testing of the new and old assemblies showed practically the same results. Some minor scratches were noticed on the surface of the piston and the cylinder. This is shown in Figure 4.

**Piston before** **Piston after 27,500 working hours**

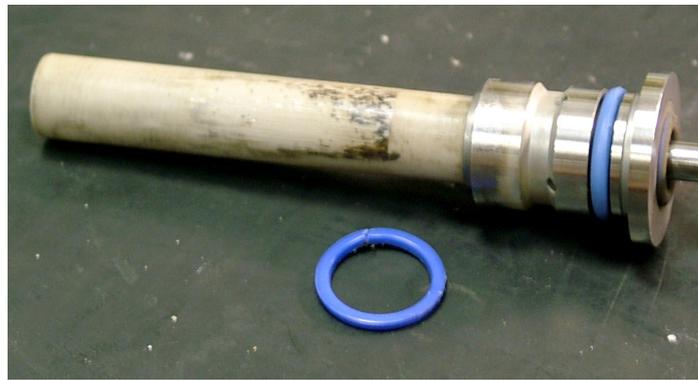
Figure 6: Cold head "after 27,500 working hours"

Figure 6 shows the technical condition of the displacer. Some minor surface contamination and scratches are seen. This however had no visible impact on the cold head performance – the same cold head was reassembled with the repaired compressor without cleaning and practically the same cooling performance was observed.
